Development of Straw Bale Building in Northern China

Yin, Xunzhi

A thesis submitted for the degree of Doctor of Civil Engineering

University of Bath

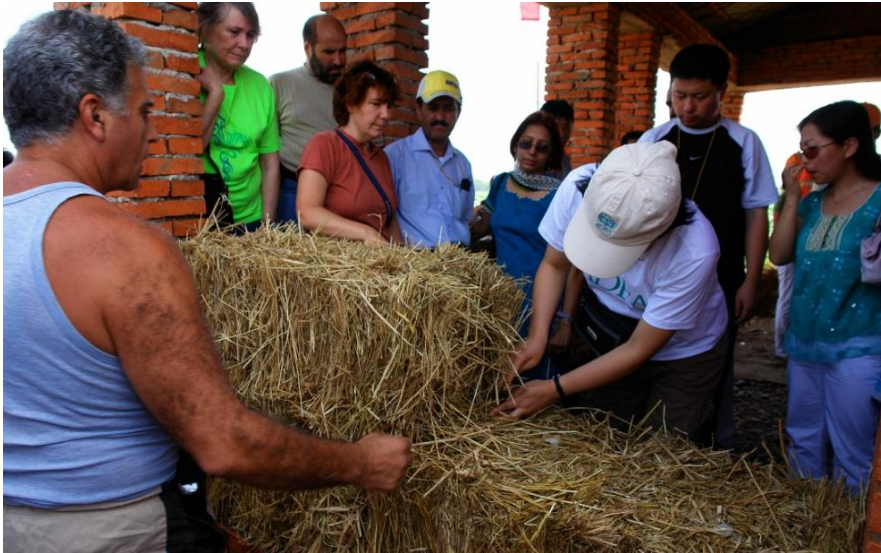
Figure 5.7. Bale stacking of straw bale walls of ADRA project.

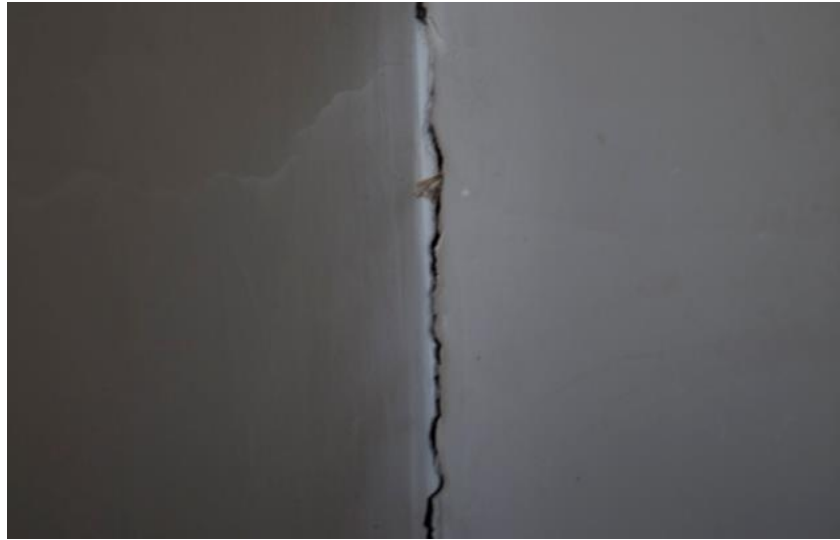
Figure 5.22. Linear cracks on an internal corner of the straw bale walls.

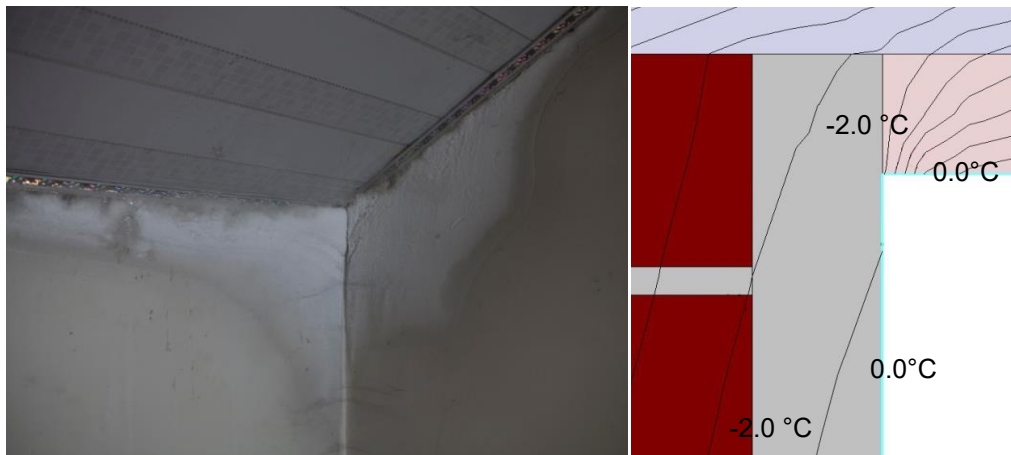
Figure 7.10. Frost issue on internal corner (left) and simulation result of the realistic joint construction within allowable range of error (right).
